Bear Creek Basin Plan

Webinar – December 12, 2016

Bear Creek Technical Webinar

Long-term Monitoring in Bear Creek

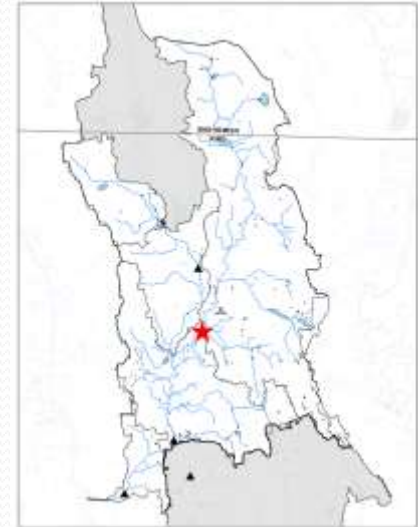
Increased frequency and magnitude of state standards violations for temperature

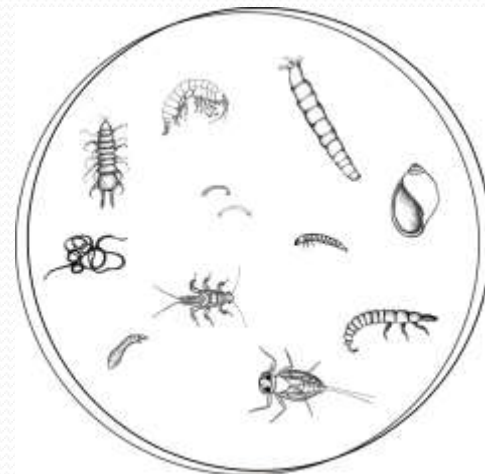
10 Metrics in the B-IBI

- Pollution tolerance/intolerance
- Taxonomic composition
- Population attributes
- Feeding and habits

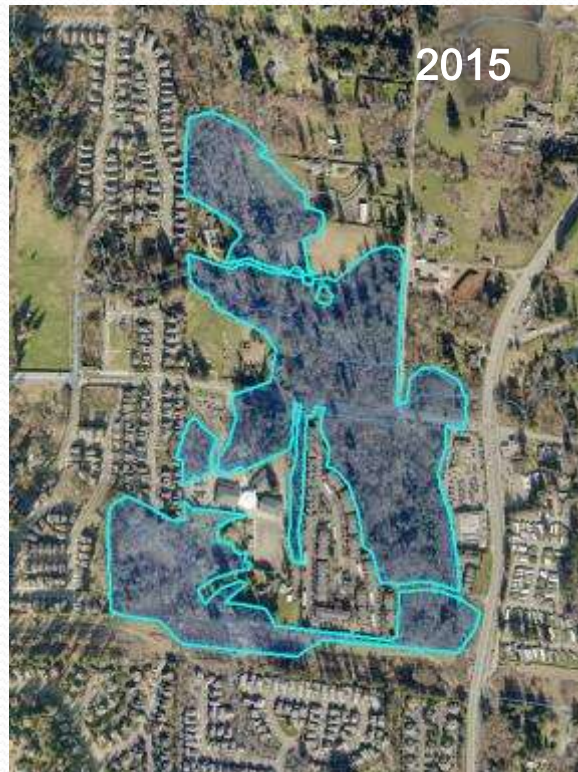
Change analysis

1990 survey: 87 acres

2015 aerial: 60.3 acres

- Visual then-and-now comparisons
- All developed areas cut out of original polygon
- Undeveloped acreage may or may not be wetland

- 20% (11 out of 54) of baseline wetlands were visibly altered since 1981-1990.
- 9 of the 11 wetlands with loss were intact in 1990, when the SAO was passed.
- This subset shows loss to mapped wetlands over past ~35 years.

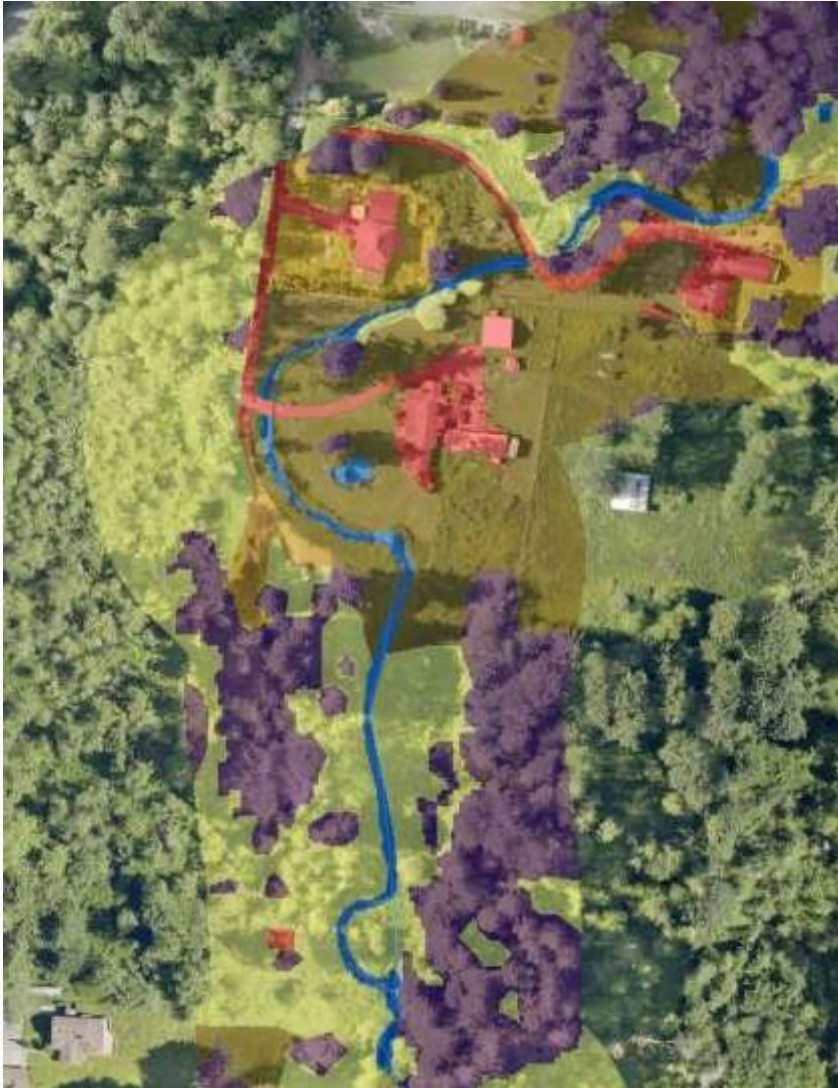
Good data!

- WDFW data as foundation for:
 - Forest
 - Impervious
- Drew in:
 - Shrub
 - Pasture
 - Non-forested Wetland
 - Water
 - Possible Beaver Dam
 - Other
- Hand-corrected on multiple passes

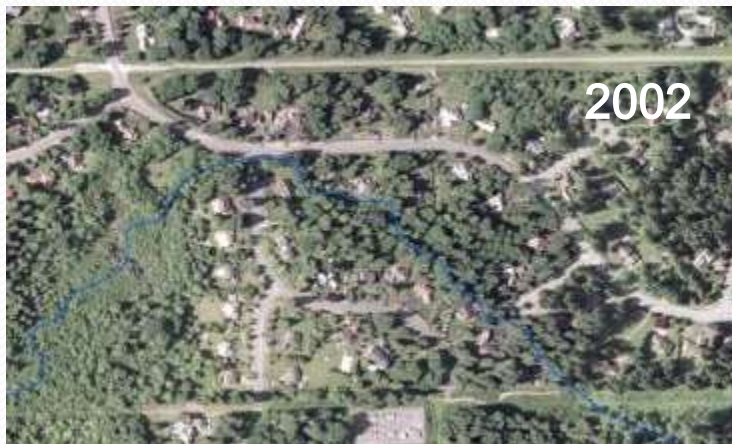
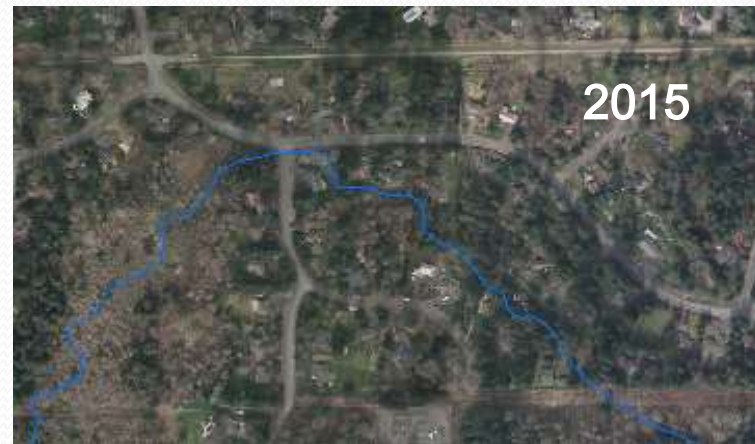
80-year progression of photos at NE 146th Way & 186th Place NE
